Technical Note: Automachron

Using Automachron to test the NTP operation of Spectracom time servers

Purpose: The purpose of this document is to provide information about using the freeware “Automachron” program to test the NTP operation of Spectracom NTP time servers (such as SecureSync, as well the Model 9100, 9200, 9300 and 9400 series NTP time servers).

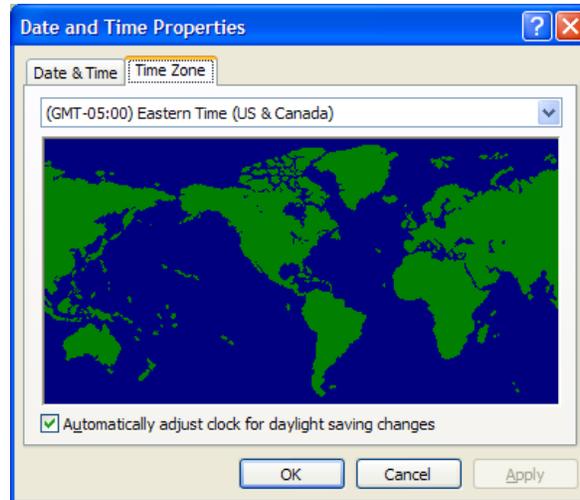
Figure 2: Windows “Date & Time” properties window

Note: If the minutes and seconds are correct but the hours are wrong, this is likely due to settings in the Windows “Date/Time Properties” window. Click on the time of the PC in the lower-right corner to bring up this configuration window (as shown in Figure 2). Verify the “Time Zone” tab has the correct geographic location selected and that the automatically adjust clock for DST check-box is enabled if your location adjusts for Daylight Saving Time change.
